Manhole Inspection Summary

Manhole # S35C__073MH

Location Address: **330 bath st**

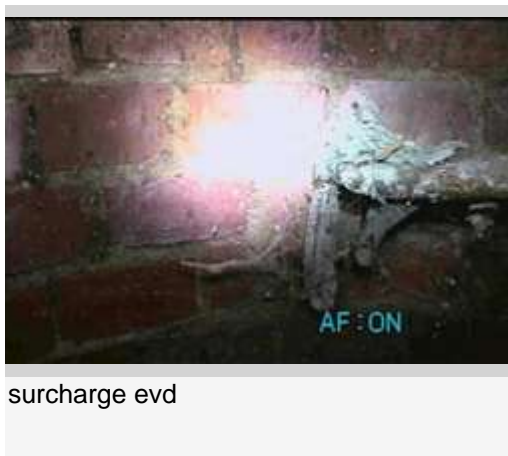
Defect 5

Surcharge ☒ **Evidence Of Surcharge** Depth: **5.5** (ft.) ☐ Active Surcharge Present

surcharge evd

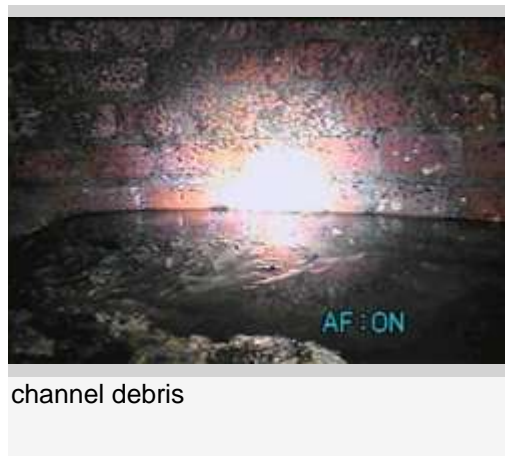
Defect 4

Condition: ☐ Sound ☐ Cracked ☐ Root Intrusion ☐ Deteriorated ☐ Leaks ☒ **Debris**

channel debris

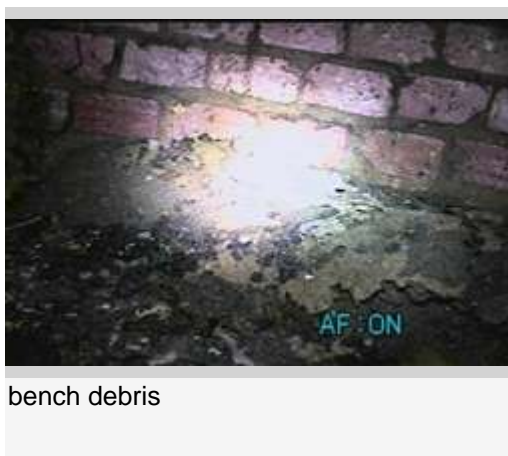
Defect 3

Condition: ☐ Sound ☐ Cracked ☐ Root Intrusion ☐ Deteriorated ☐ Leaks ☒ **Debris**

bench debris

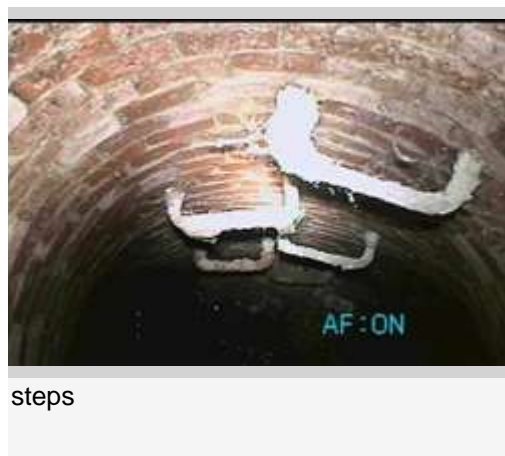
Defect 2

Steps Count: **5** Missing: **0** ☒ **Corroded**

steps

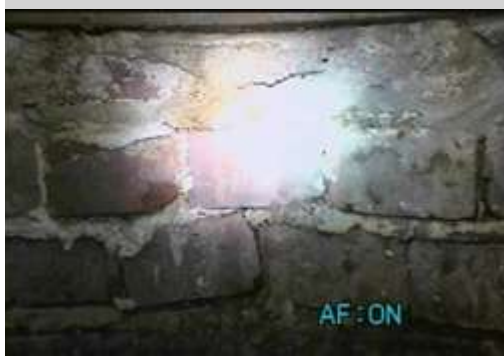
Defect 1

Condition: ☐ Sound ☐ Cracked ☐ Root Intrusion ☐ Loose Brick ☒ **Deteriorated**

chimney deteriorated,
frame adj

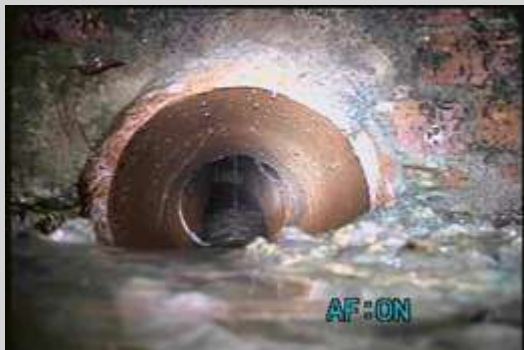
12 O'Clock Outflow

10 in. Circular Gravity Sewer
Pipe Out @ 12 O'Clock

Pipe Material: **Clay** ☐ Pipe Lined

Invert Depth: **9.66** (ft.) Flow Characteristics: **Slow**

Infiltration: **None** Pipe Seal Cond: **Unknown**

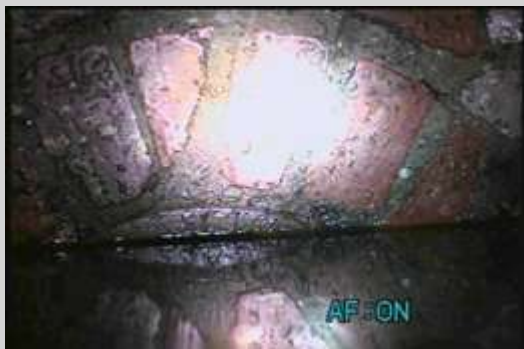
5 O'Clock Inflow

10 in. Circular Gravity Sewer
Pipe In @ 5 O'Clock

cant see in 5

Pipe Material: **Clay** ☐ Pipe Lined

Invert Depth: **9.41** (ft.) Flow Characteristics: **Slow**

Infiltration: **None** Pipe Seal Cond: **Unknown**
